# Intel® Pentium® 4 Processor

## Specification Update

*March 2003*

Document Number: 249199-034

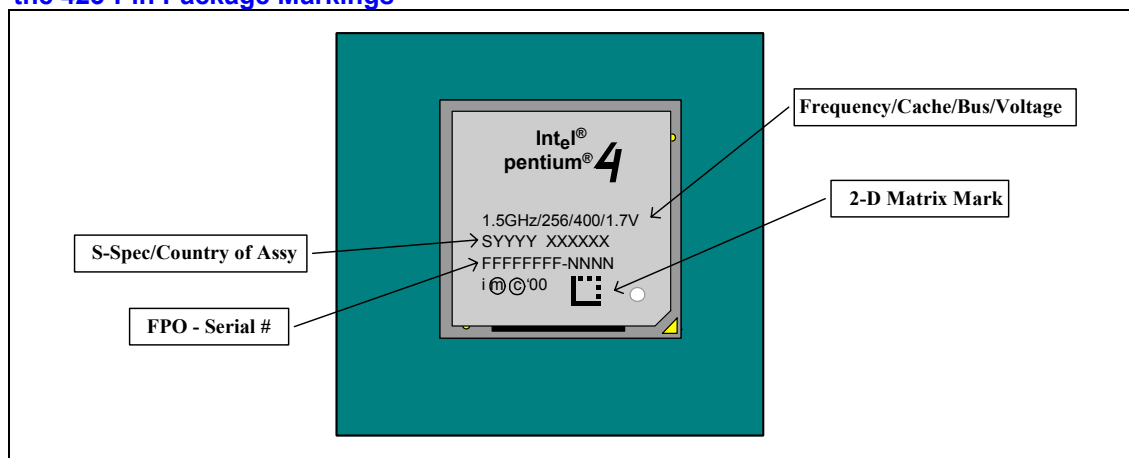
**Figure 1. Intel® Pentium® 4 Processor in the 423-Pin Package and Boxed Pentium 4 Processor in the 423-Pin Package Markings**

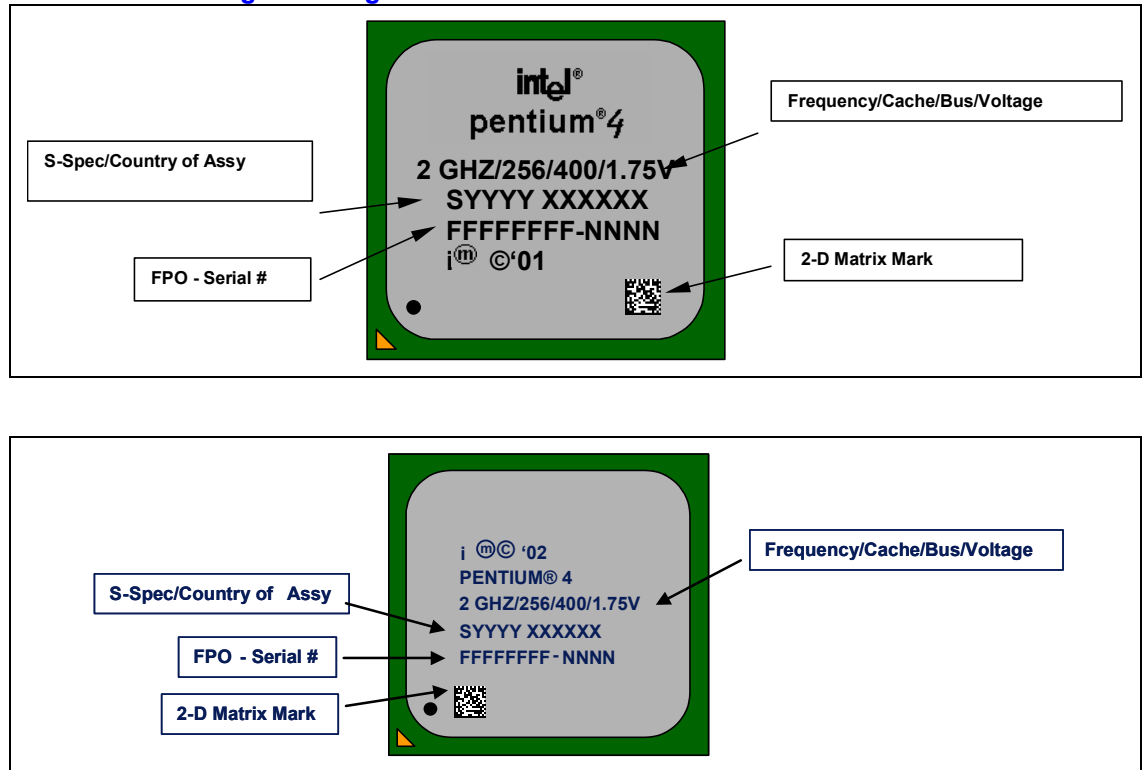
Figure 2. Intel® Pentium® 4 Processor in the 478-Pin Package and Boxed Pentium 4 Processor in the 478-Pin Package Markings

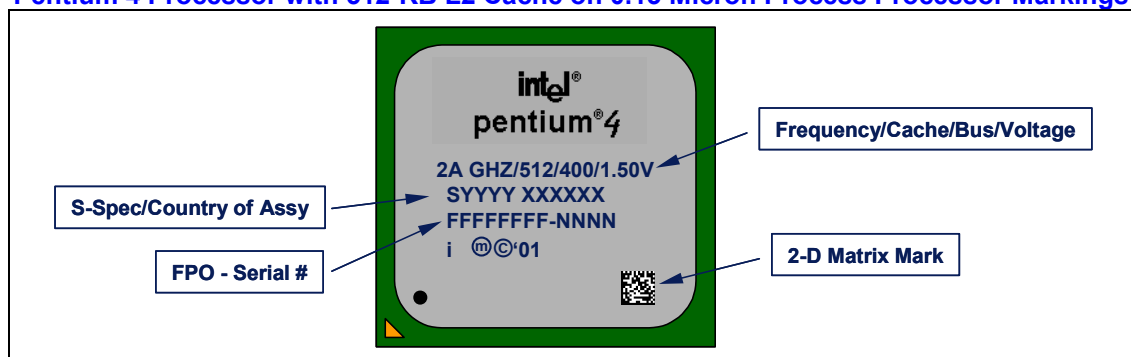
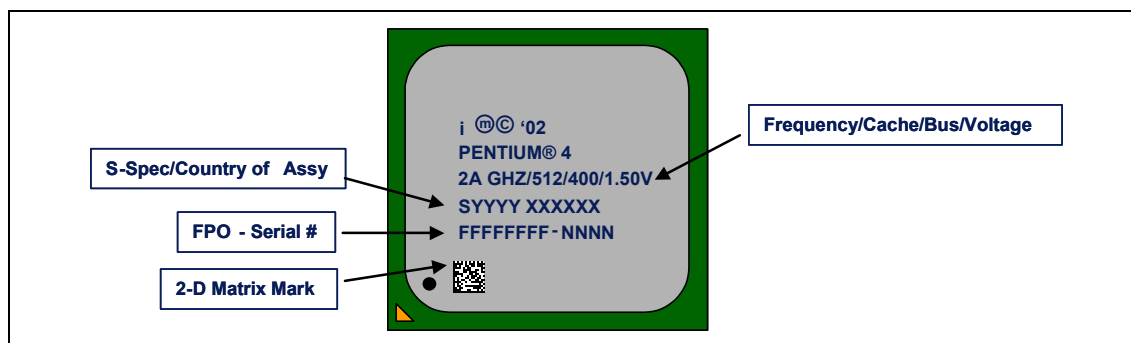
**Figure 3. Intel® Pentium® 4 Processor with 512-KB L2 Cache on 0.13 Micron Process and Boxed Pentium 4 Processor with 512-KB L2 Cache on 0.13 Micron Process Processor Markings**

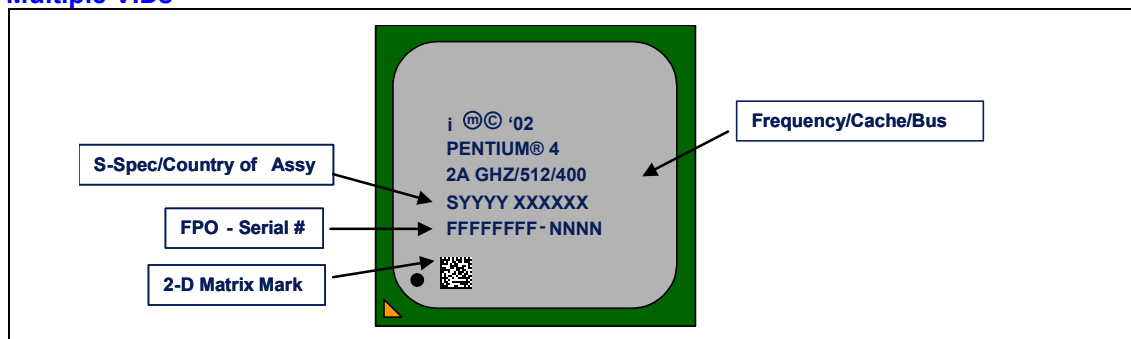
**Figure 4. Multiple VIDs**
